Asbestos in Emergencies:

Safer Handling and Breaking the Cycle

Disaster Waste Recovery

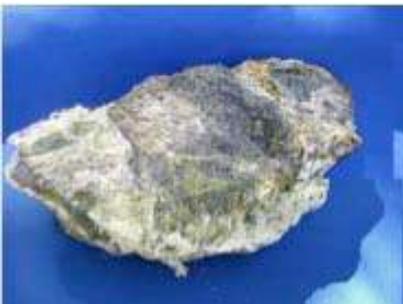
Chrysotile asbestos

- **Chrysotile** (white asbestos) has a very good resistance to alkalis. It is the most common type of asbestos, accounting for over 90 per cent of asbestos mined annually. It is most frequently found in asbestos-cement products such as roofing sheets.
- **Amosite** (brown asbestos) has a very good resistance to high temperature and is used in thermal insulation products and ceiling tiles.

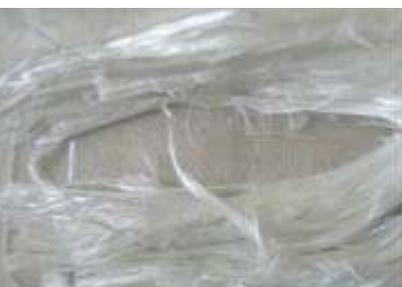
Asbestos fibres

Friable asbestos presents very serious health risks as asbestos fibres are loose and easily released into the air. Breathing these fibres causes serious lung diseases. Loose fibres are so small that they are not normally visible and are not stopped by dust masks alone.

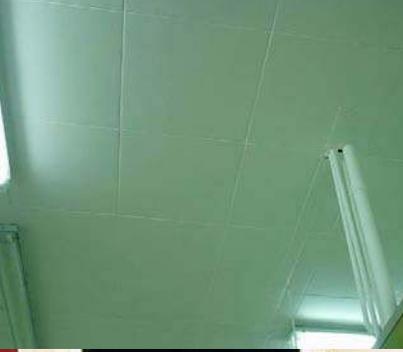
Asbestos insulating boards have typically been used for ceiling boards and false walls. Asbestos vinyl floor tiles are also common. Bituminous tar paste was widely used to glue down linoleum tiles, particularly in commercial buildings and hospitals built in the 1970s.

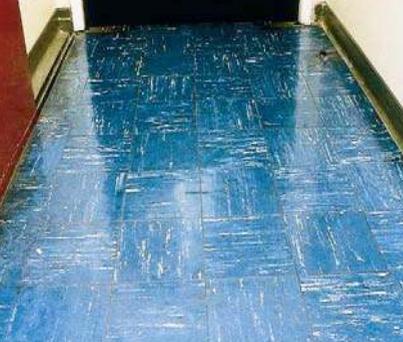
Asbestos has been sprayed in buildings for sound-proofing and fire-proofing in developed countries. In the late 1950s, it became virtually standard practice for large buildings, hospitals and schools to have sprayed asbestos on steel columns, beams and roofing sheets. This form of asbestos is highly friable and highly dangerous if damaged or in poor condition, and has a high asbestos content of around 85 per cent.

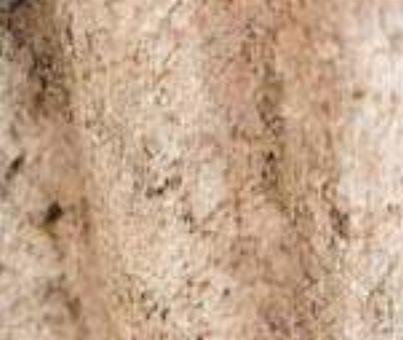
Since the 1950s asbestos insulation was commonly used for insulating boilers, hot water tanks and hot water and steam pipes. It can be sprayed or used as loose fibres, also known as fluff form. It can also be used as a cloth wrap for other non-asbestos insulating products. Insulation of this type is highly friable and dangerous and can contain over 90 per cent asbestos.

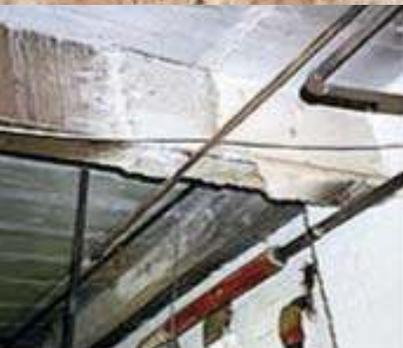
Asbestos containing artex was used widely as a coating in residential and office blocks, schools, hospitals and nursing homes in Europe.
